# **Ovako Imatra - Case Study Report of a heavy duty Industrial gear restored with RVS Technology treatment.**

**The device in question is a Drift Gear, location: 6040KÄ01, Gear brand: Danieli, type: GPR.550.13, number 77.78.623**

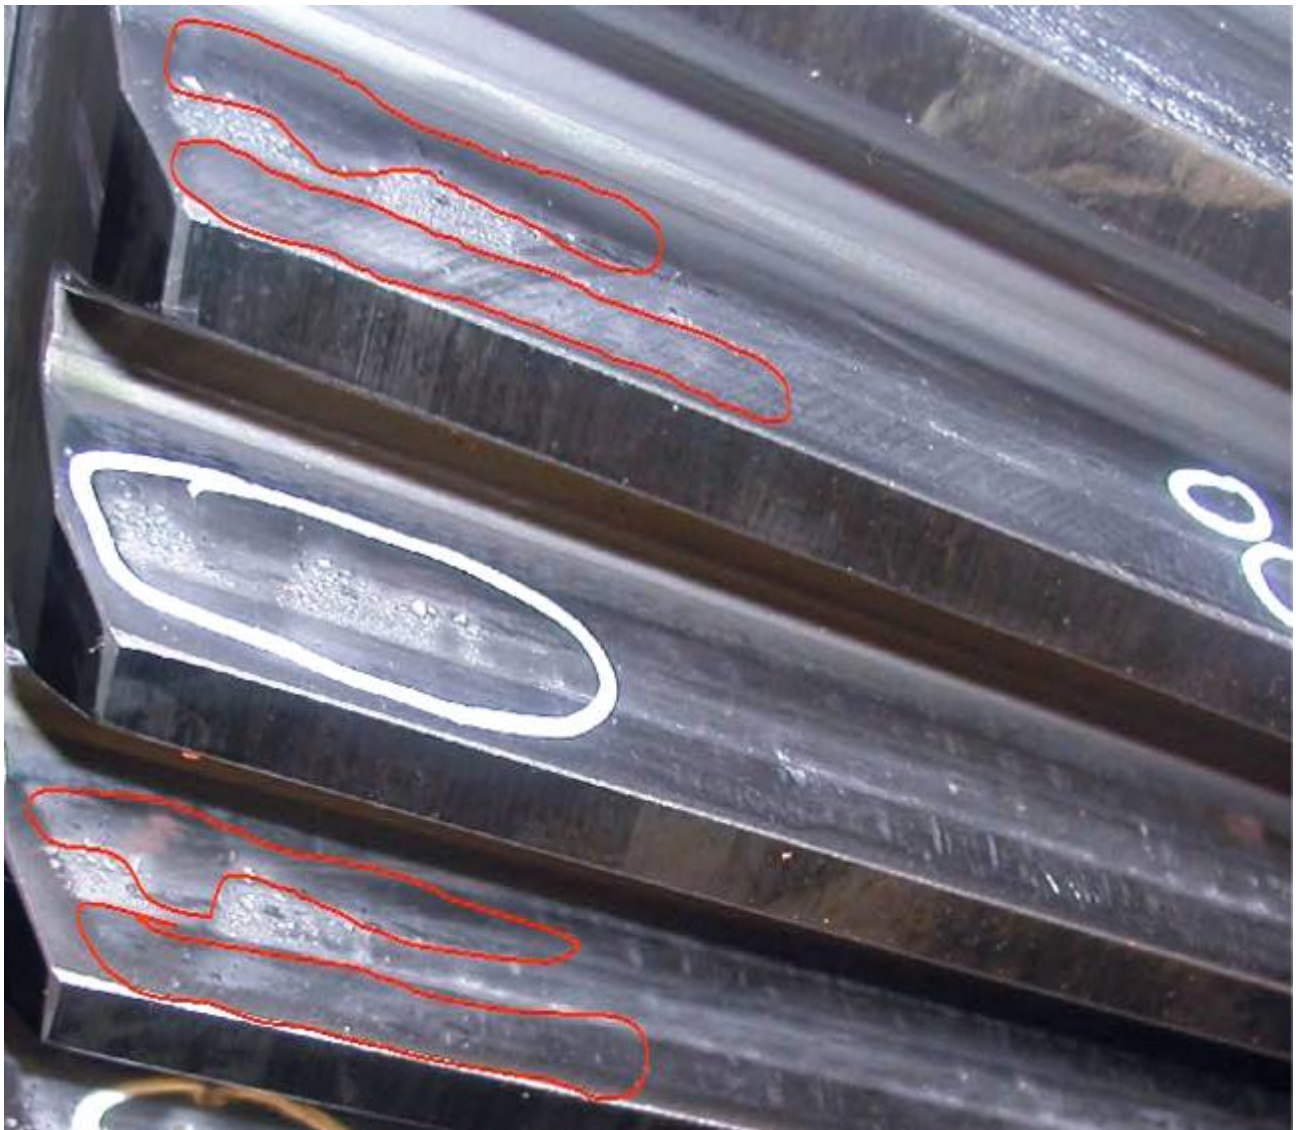
27.09.2003, the "motor side" gear

Traces of earlier strong pitting are detected. The pictures show that the teeth have now partly been covered with TriboCeramic compound. TriboCeramics area has been marked with red color on some teeth. The existence of the ceramic appears as a polished area around and on the pitting pits. The pits are "filled and leveled" with TriboCeramics.

Pictures have been taken in three sequences, 27.9.2003, 21.5.2005 and 10.12.2011. The RVS Technology treatment was carried out on 11.3.2003 by applying RVS compound into the oil tank that locates ca. 10 m away from the gear. The oil filter was by-passed during the first eight (8) treatment hours. The situation before RVS application was not pictured.
